Reeves House Condominium  
401 East Robinson Street  
Orlando, FL 32801  
CC: The Board at Reeves House Condominium

December 20, 2024  
LEI Job #: 22235

## PHASE I MILESTONE INSPECTION REPORT

## REEVES HOUSE CONDOMINIUM

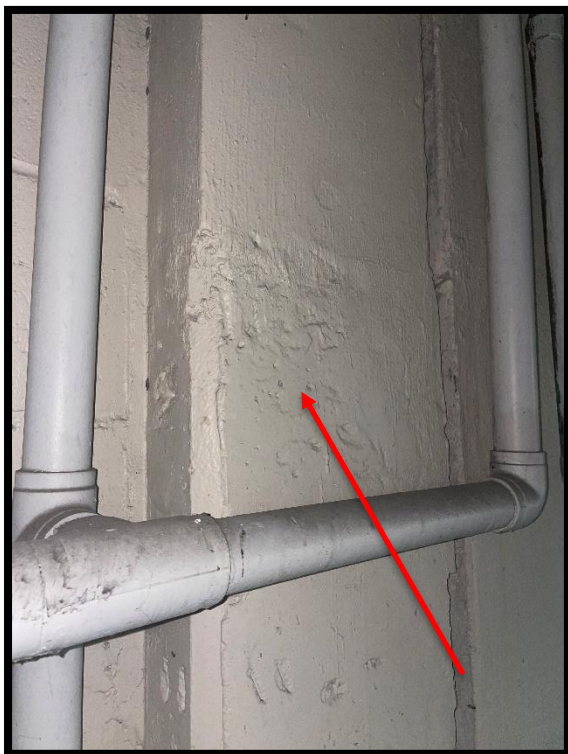
*Minor spalling on concrete substrate*

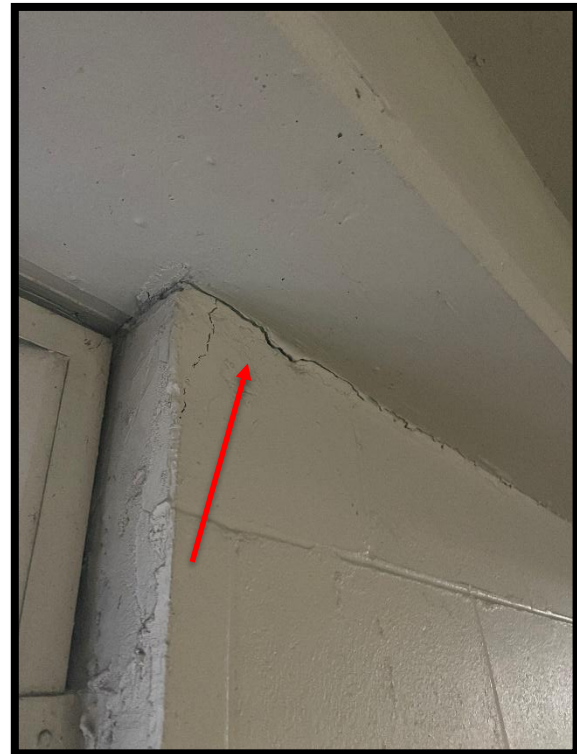
**Observations & Assessment:** We examined the concrete slab-on-grade as well as the column base connections where the reinforced concrete footers are located (below grade) and did not note any moderate to significant cracking or spalling that would potentially indicate signs of one-way or two-way localized shear failure. The surface condition of the slab is in relatively fair condition with minor surface imperfections. Surface sloping appeared adequate as we did not observe areas with signs of excessive moisture exposure or damage. We assessed and measured the deflections of multiple tie-beams throughout the parking garage with a commercial-grade, self-leveling laser and did not record any measurements outside an acceptable threshold. The tie-beams appeared sound and mainly in-tact showing very small signs of spalling. We observed several hairline fractures in various areas around the parking garage, but the age of the cracks could not be determined. There were some separation cracks around the perimeter at the CMU block to tie-beam transition potentially from minor settlement

*Separation crack @ perimeter wall*

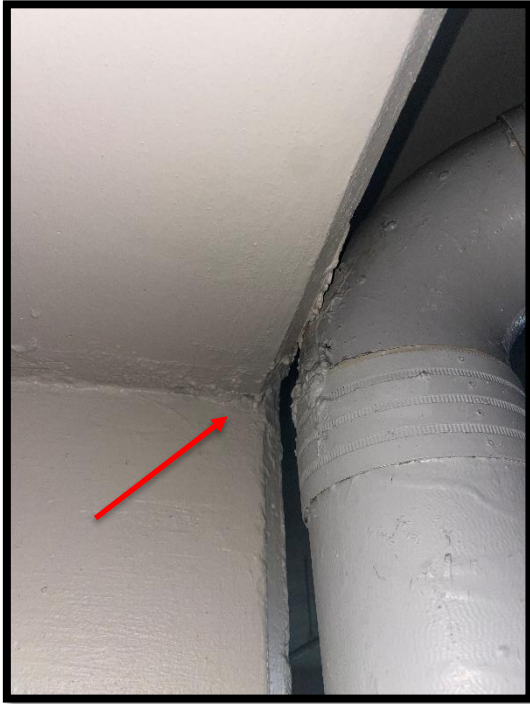
*Recent touch-up on tie-beam*

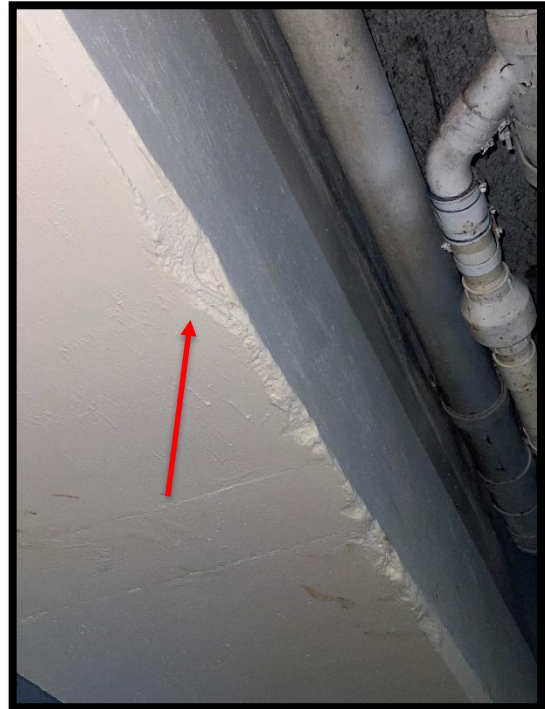
*Minor spalling on tie-beam*

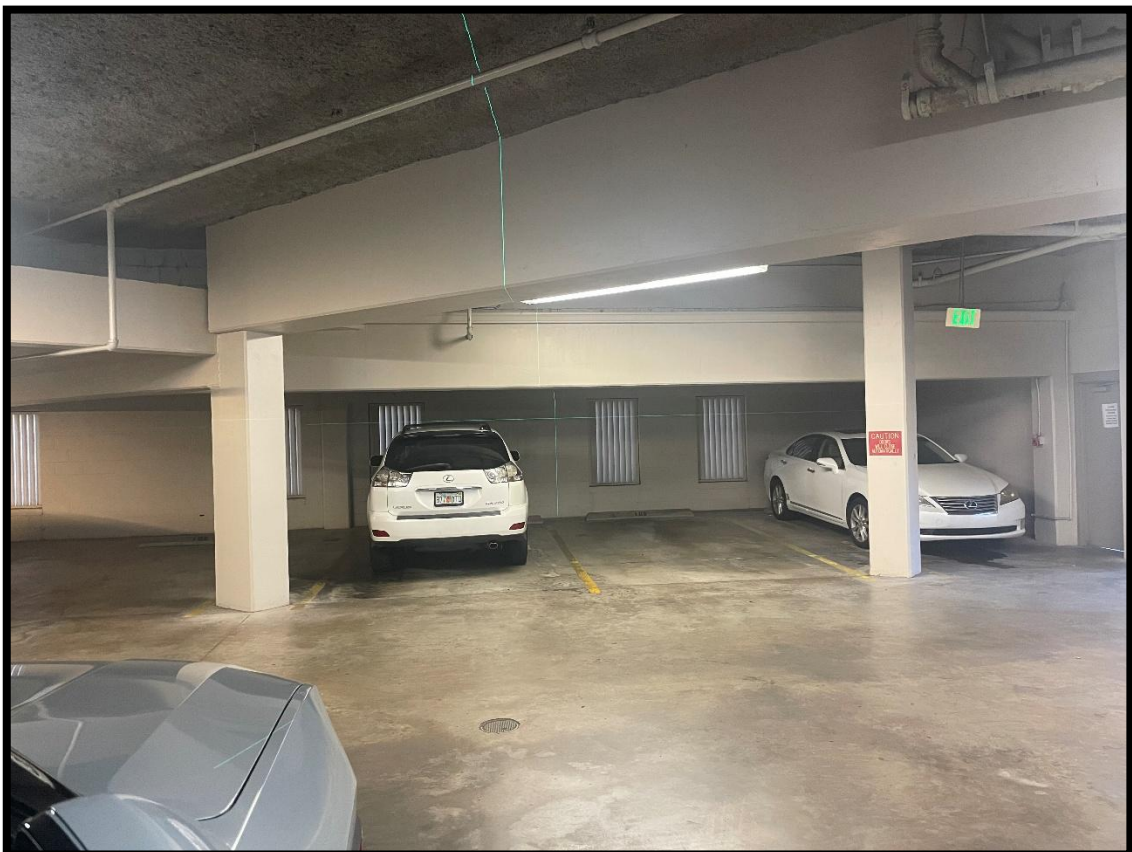
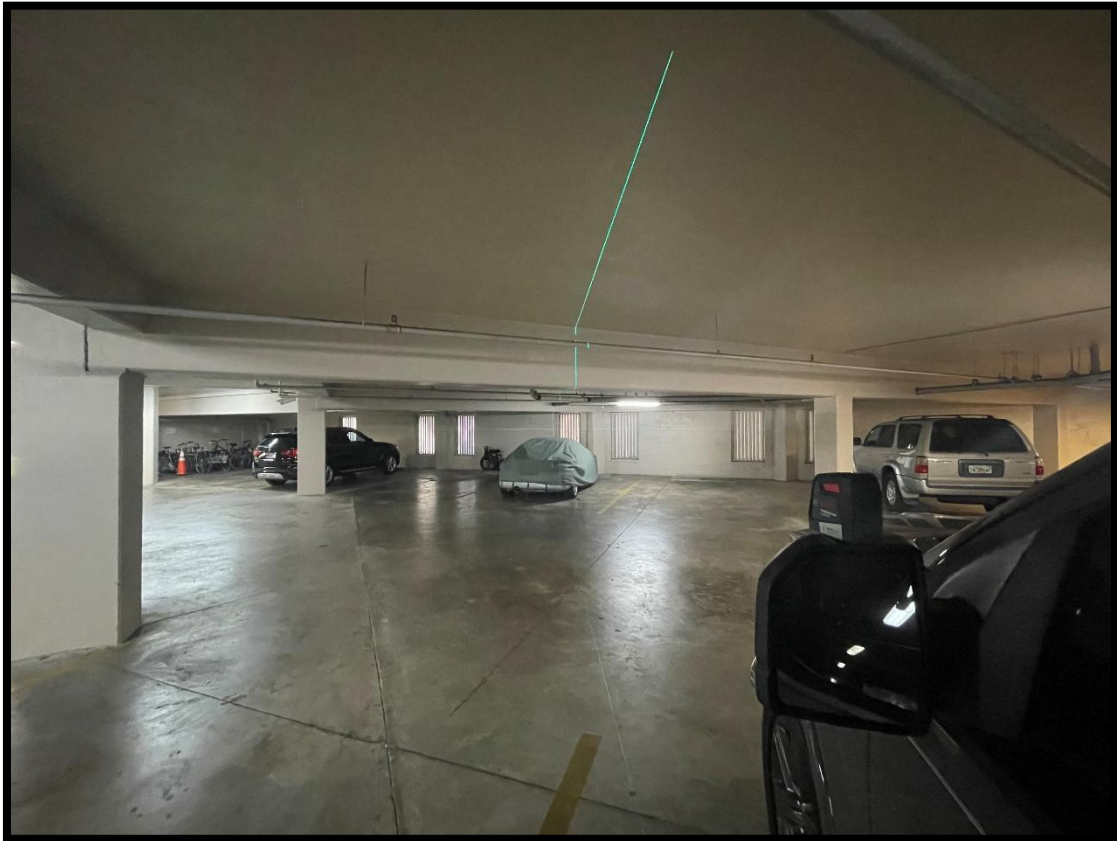
*Beam deflection (performance) assessment*

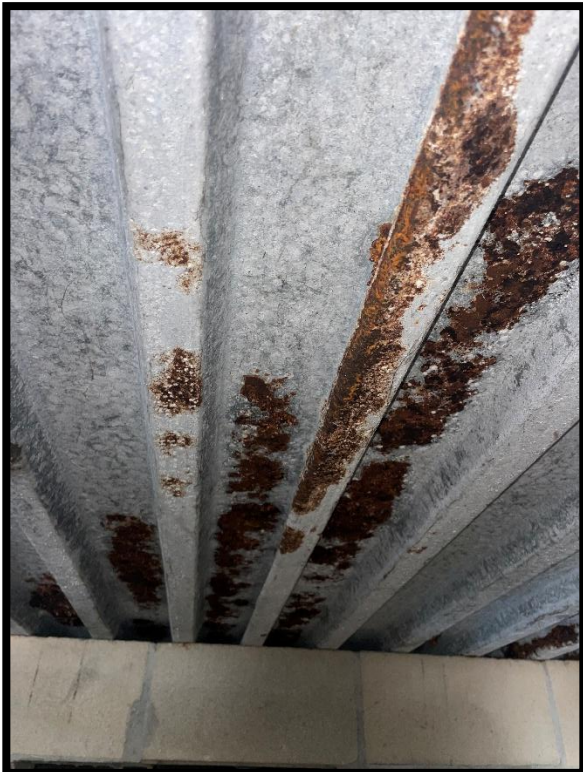
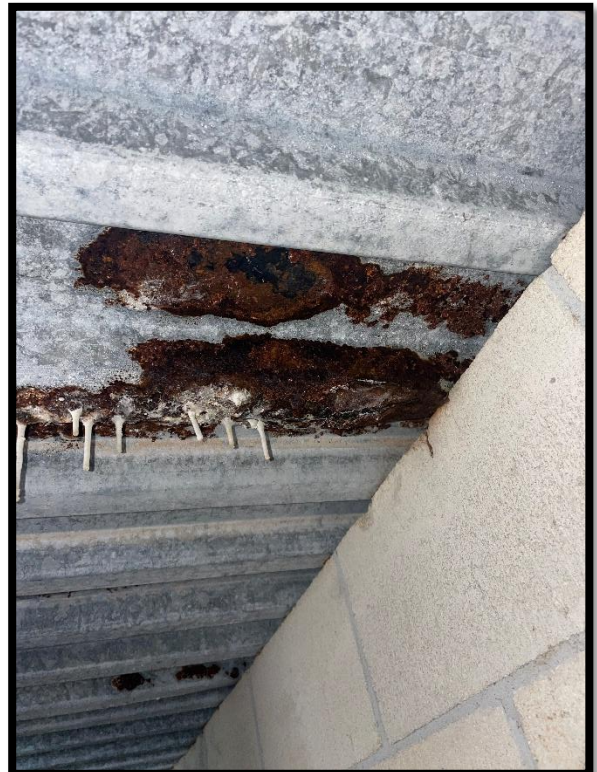
*Corroded areas on metal pan and ribs*

**Opinion:** The sun deck, pool deck, pool, spa, and guardrails are currently performing; we did not observe signs of structural degradation or displacement. Although we did identify corroded areas of the corrugated metal deck that structurally support the concrete slab and pool deck, the damage was localized in areas where leaks had likely previously occurred. Over time, the pan will continue to degrade as the corrosion spreads which may require localized repairs in the future; however, we do not believe any immediate repairs are required based on the fact that the pan is both performing and mainly in-tact.

Any items requiring remedial or preventative repair that are damaged but not substantial structural deterioration? YES – minor cracking observed should be routinely monitored and patched to avoid moisture penetration. Additionally, the galvanized metal deck may require localized repairs in the near future if the corrosion continues to degrade the material impacting the performance.

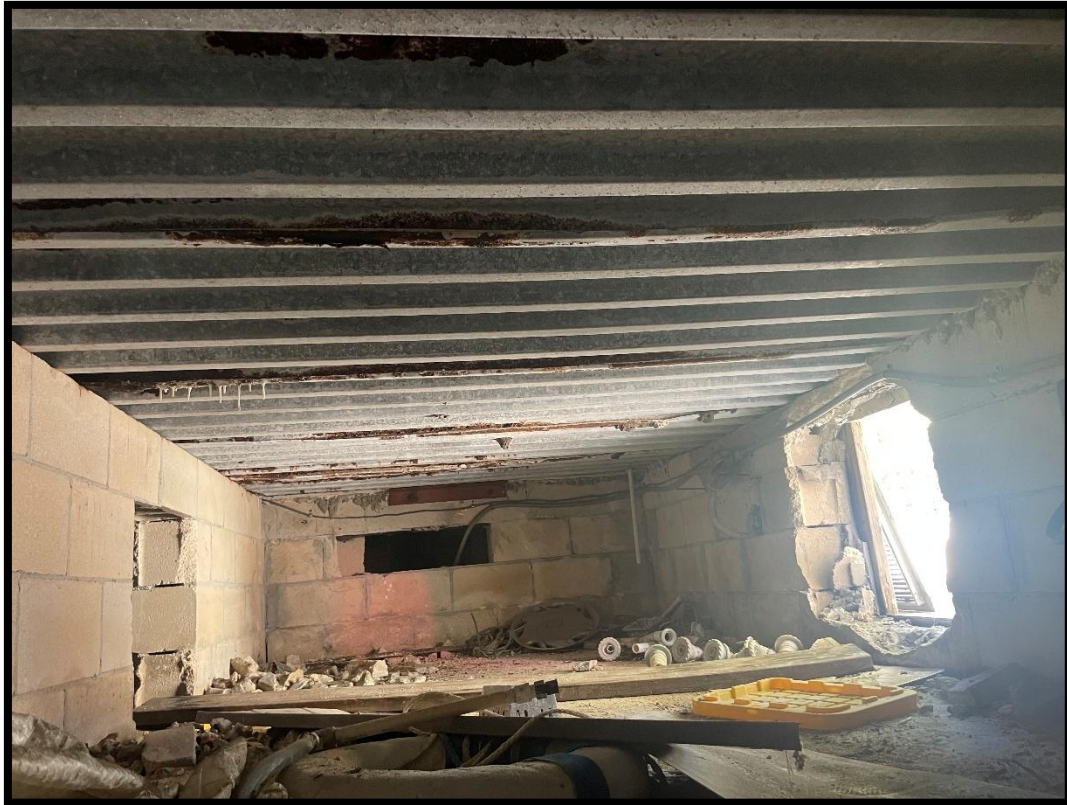
*Metal pan bearing on CMU block stem wall*

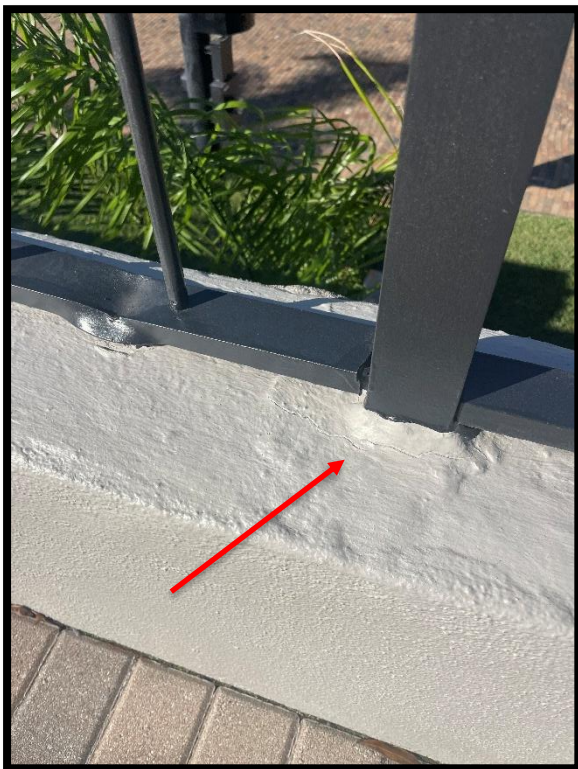
*Minor cracks at post pocket*

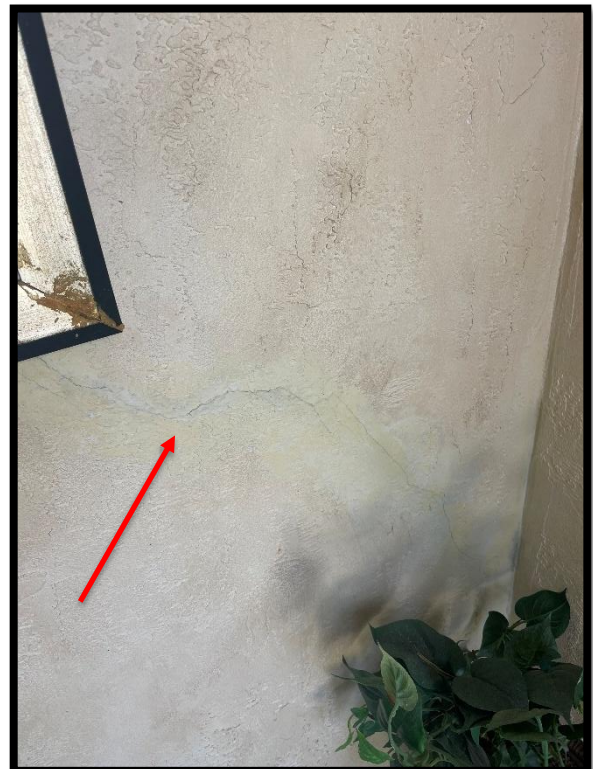
*Repaired drywall crack in bathroom*

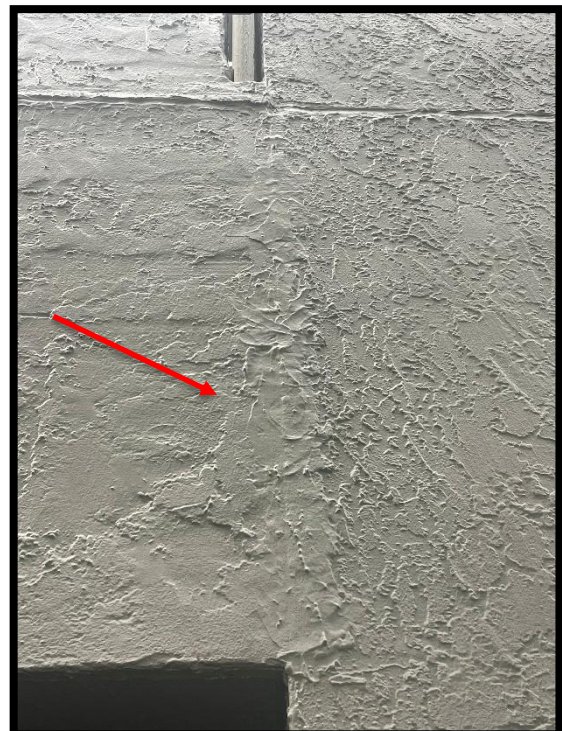
*Recent touch-up on the stucco façade*

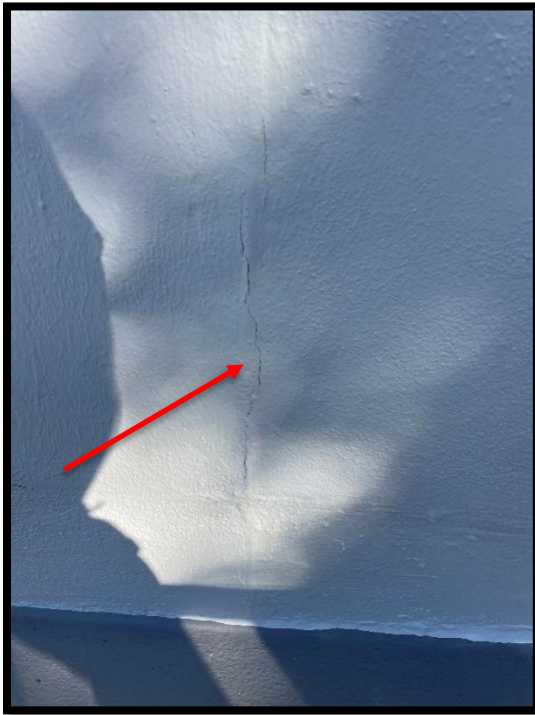
*Hairline fracture in Stucco Façade*

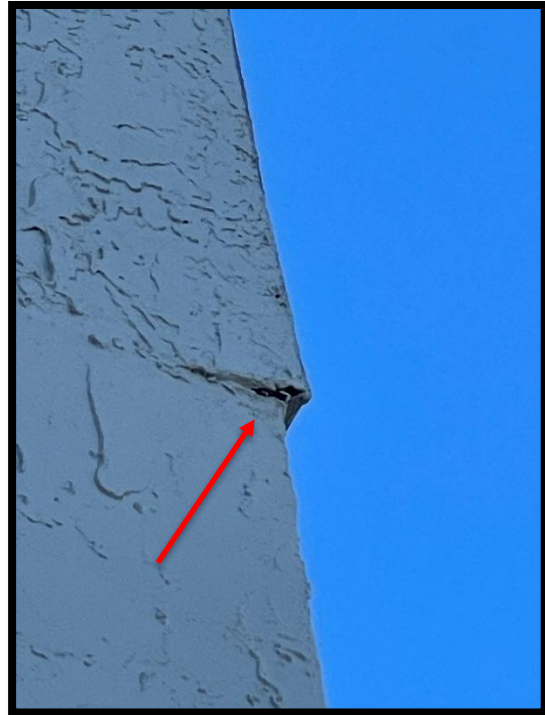
*Small breach in Stucco Façade*

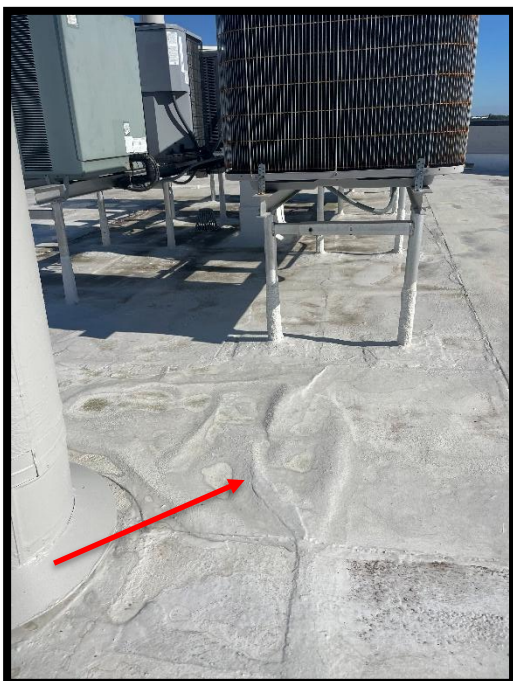
**Observations & Assessment:** The modified bitumen roof appeared original with evidence supporting that the roof had recently been coated with a sealant. We did note that the roof appeared aged, with several cracks and bubbling present within the roofing material in various areas. There were several water stains as well as signs of minor ponding primarily below the mechanical equipment on the roof. Although the pitch of the roof seemed adequate for drainage, we did observe areas where water was collecting on the surface and unable to drain through the roof drains and or scuppers in the parapet wall. It is also important to note that no

*Surface bubbling*

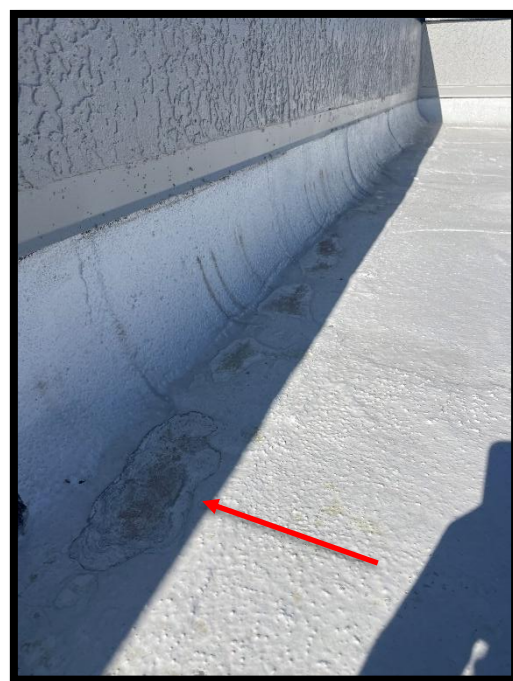
*Water stains*

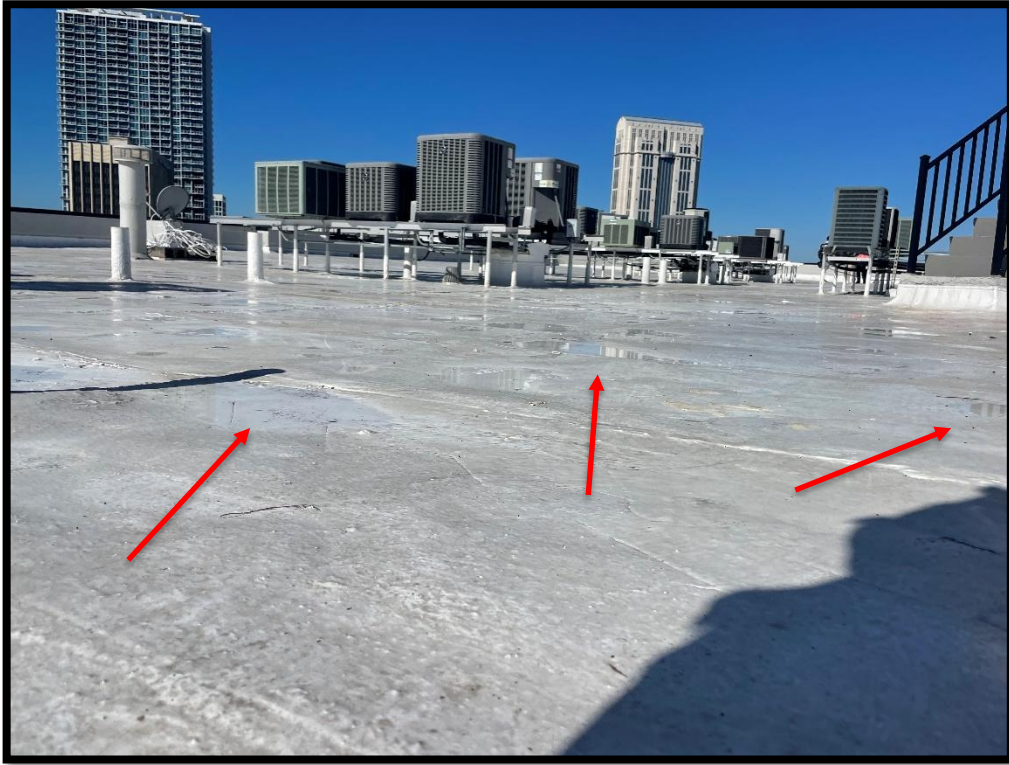
*Areas with minor water ponding*

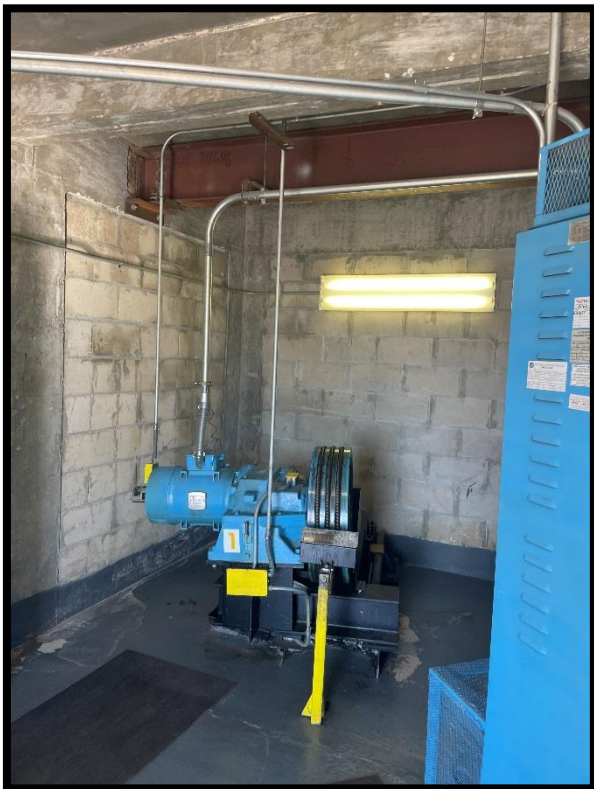
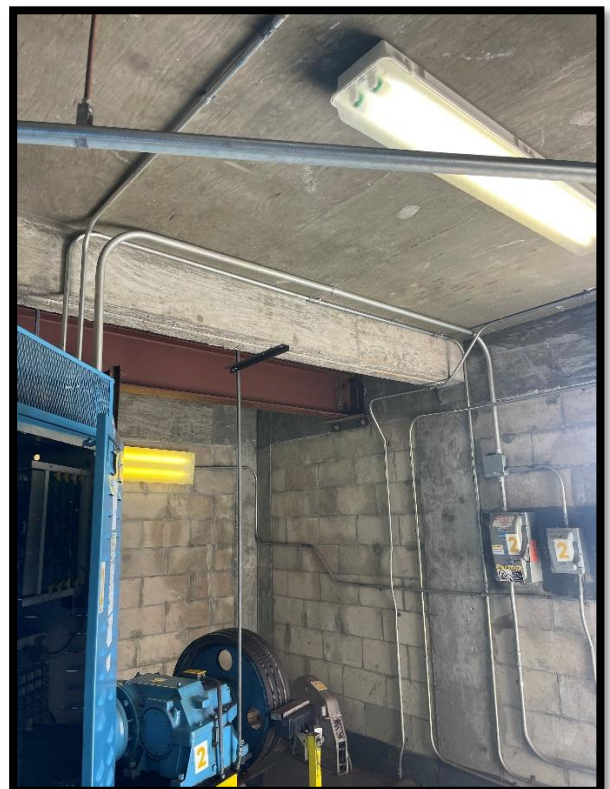
known leaks on the seventh floor below have been reported by any of the occupants. The housing structure for the machine drive and control center appeared to be of sound condition; we did not observe any concerning cracks or damage to the steel I-beam or surrounding structural components.

*Elevator housing structure*
