Reeves Condominium
401 E. Robinson St, Orland, FL 32801

Structural Integrity Reserve Study
Projection Period Beginning January 1, 2025

December 31, 2024

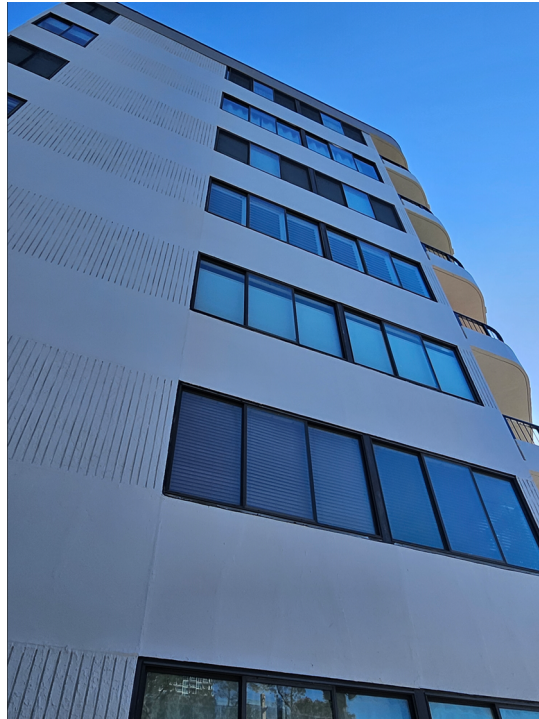
Condition: Good overall. Major repairs were conducted in 2024 under a exterior surface painting.

Component detail notes: Repairs for masonry exterior finishes are crucial to address issues such as cracking, spalling, and deterioration caused by exposure to humidity, moisture, and extreme weather conditions common in Florida.

- Re-stucco: This involves repairing approximately 20% of the total area of the building surface;
- Re-caulking windows and doors: re-caulk a total length of 6,500 linear feet around the windows and doors to ensure proper sealing and protection against moisture intrusion
- Painting: paint approximately 30,000 square feet of the building's exterior surfaces to enhance its appearance and protect it from the elements.

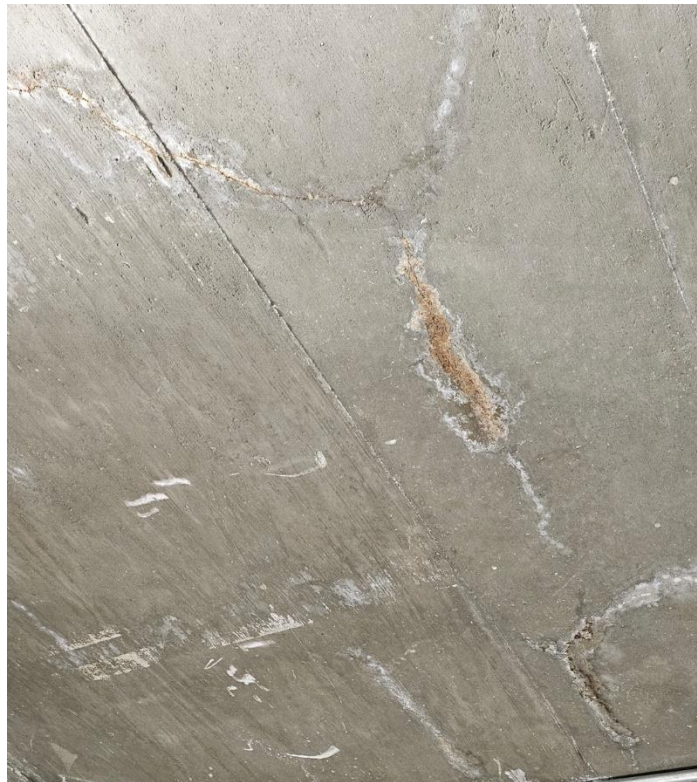
Condition: Good overall. Minor slab cracks or beam concrete spalling observed at the garage beams. Refer to the milestone inspection report.

Picture of the elevator bulkhead roof slab with a visible crack underside of the concrete slab

- Assessing and repairing any cracks or damage in the concrete framing.
- Reinforcing or replacing deteriorated reinforcement bars (rebar).
- Patching or resurfacing concrete surfaces as needed.
- Addressing any structural weaknesses or deficiencies identified during the inspection.

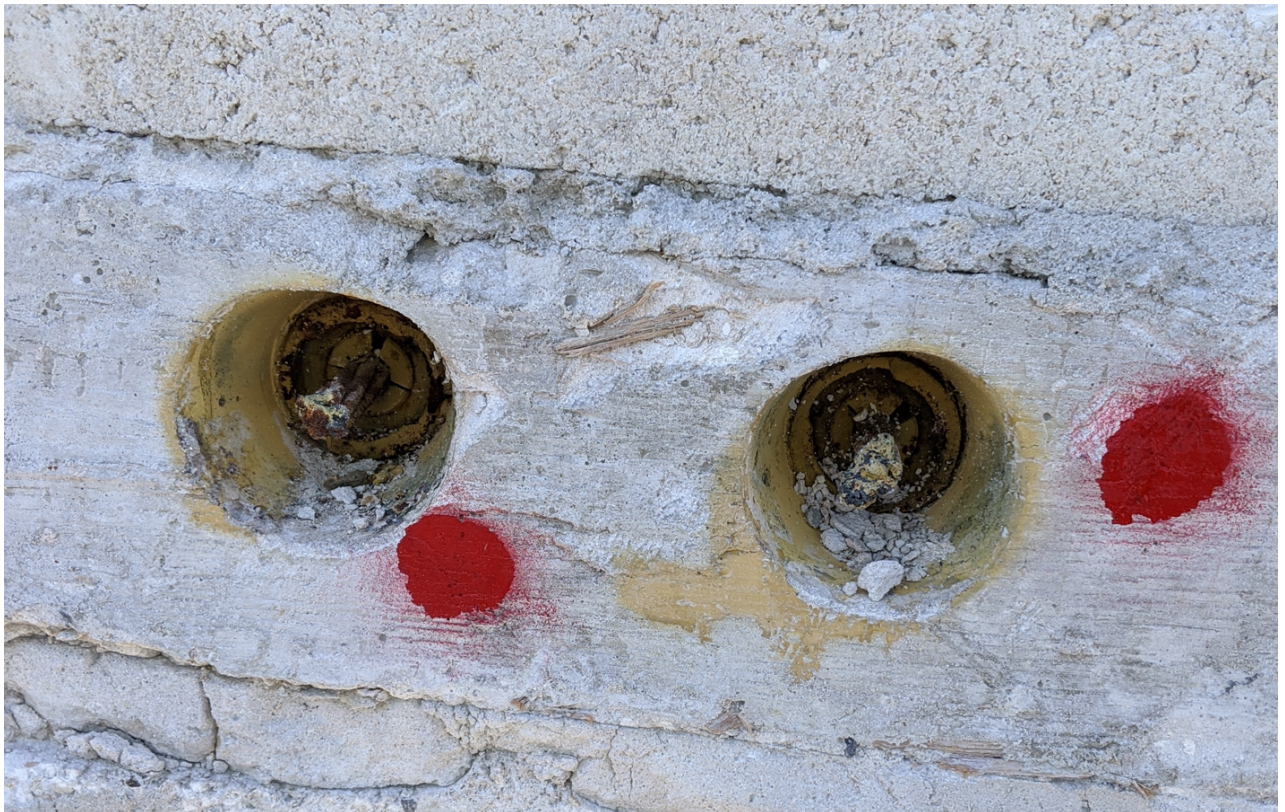
Condition: The anchors condition were consiled and not visible for inspection.

Picture of the typical tendon anchor corrosion of the slab edge.
(Just an example from the same age building)

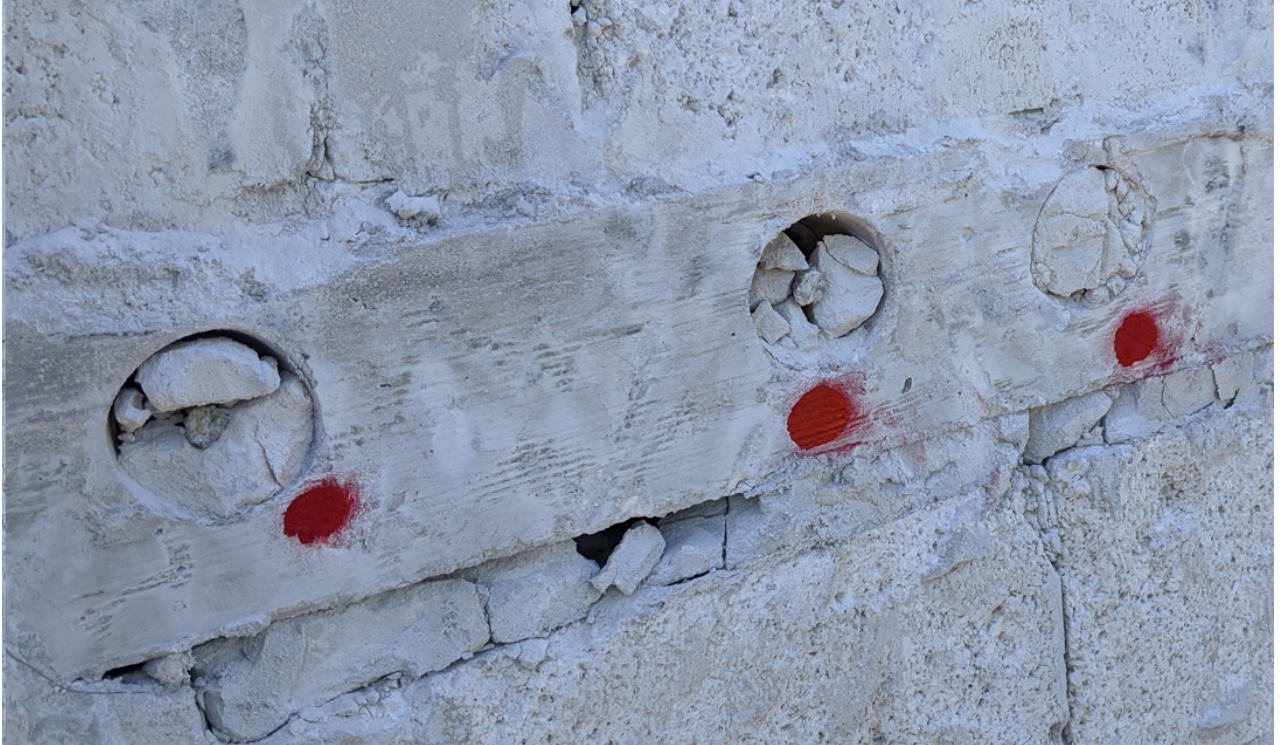
Condition: The pockets condition were consiled and not visible for inspection.

Picture of the typical PT pocket on the slab edge.
(Just an example from the same age building)

- Remove unsound concrete from the pocket;
- Clean, then coat tendon anchor and concrete around anchor w/ migrating corrosion inhibitor;
- Form and patch per concrete repair procedures.

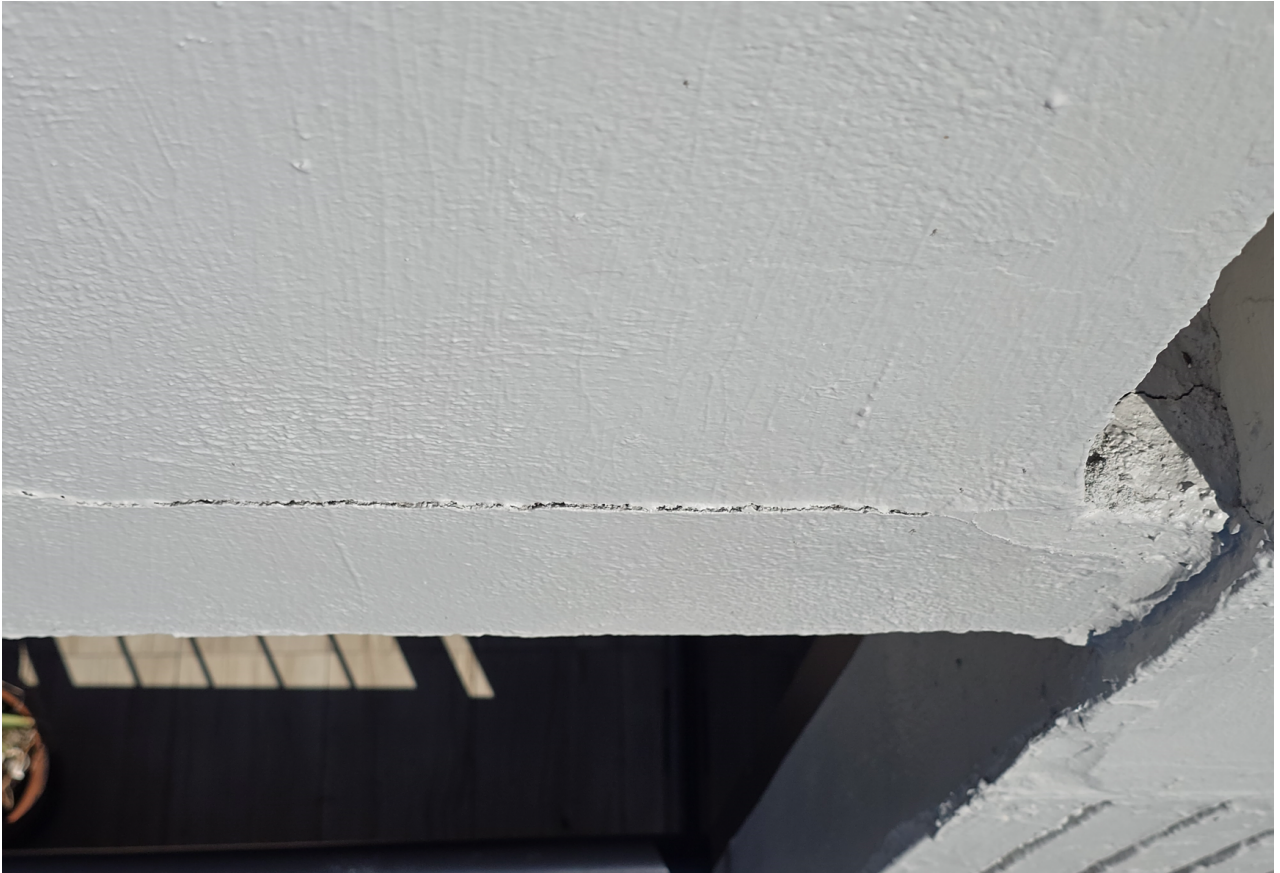
Picture of the balcony typical slab edge deterioration. PH level.

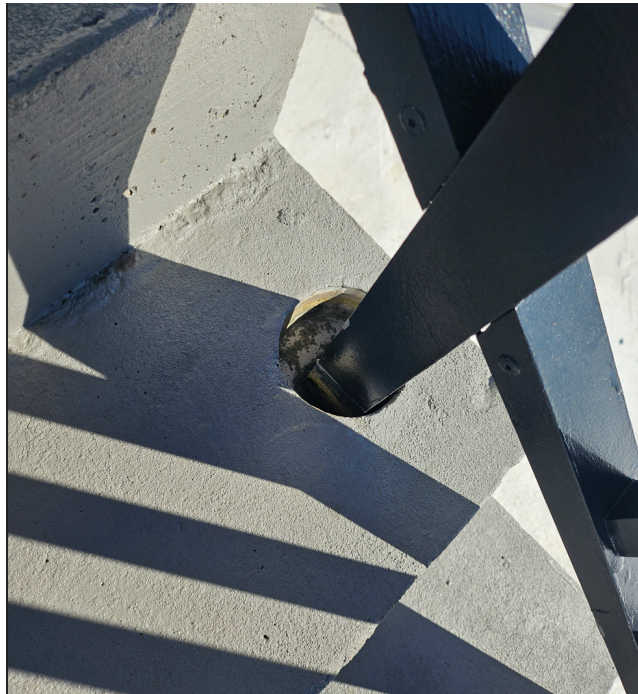
Picture of the typical post-pocket deterioration.

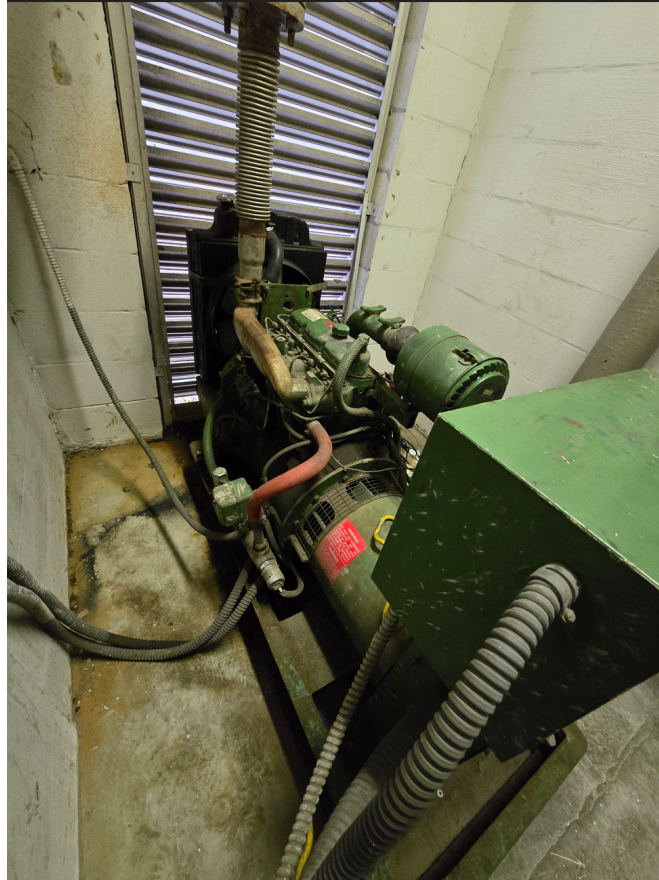
Condition: Not suitable for the proposed elevator modernization project.

Picture of the current generator.

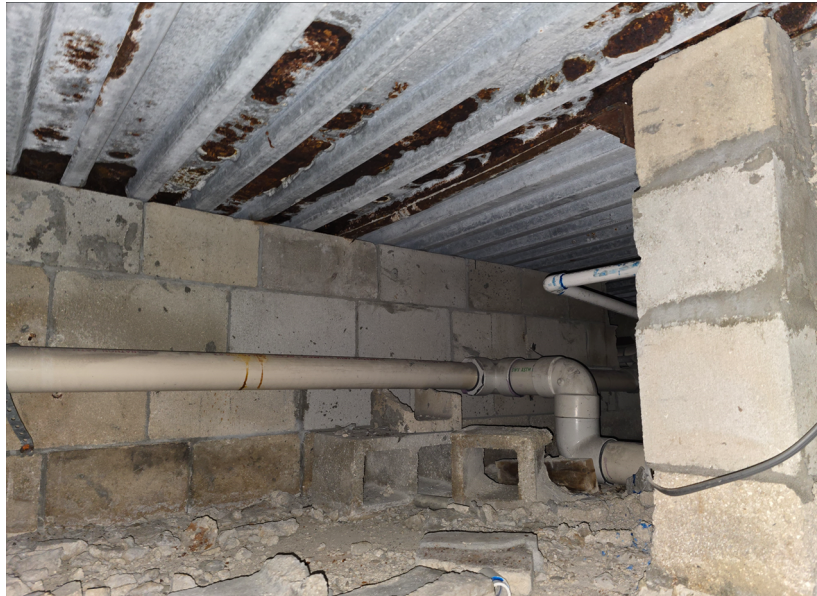
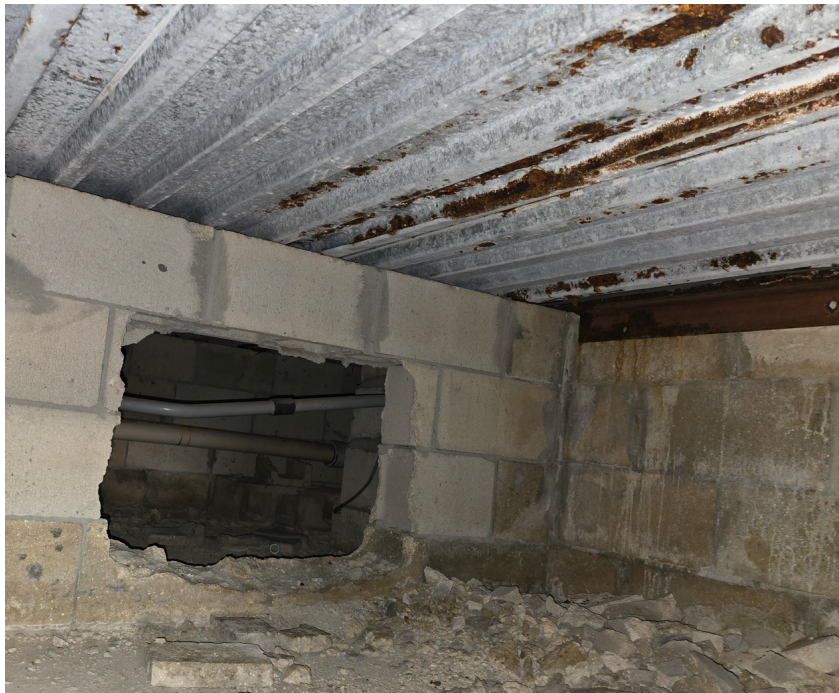
Condition: Water leaks have been observed under the deck, and part of the metal deck shows signs of corrosion.

- Demolition of the existing concrete slab over the metal deck in the specified deck area.
- Repair supporting CMU knee wall openings with new precast lintels.
- Installation of new 1 5/16" metal deck and pouring of a 4" thick concrete slab.
- Installation of stone pavers using existing materials.
